# Single-Ply EPDM Coatings Restoration Case Study

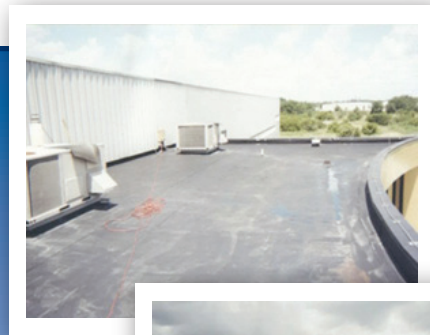
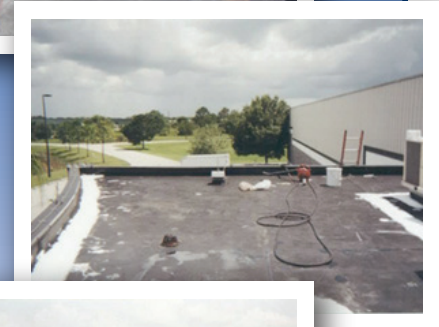
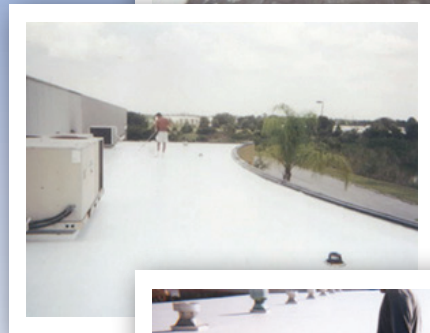
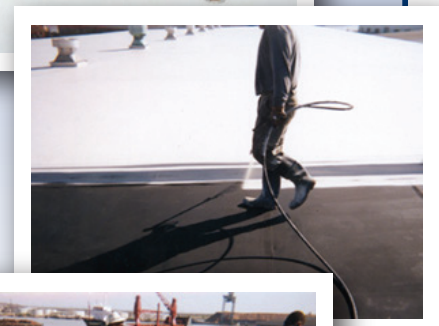
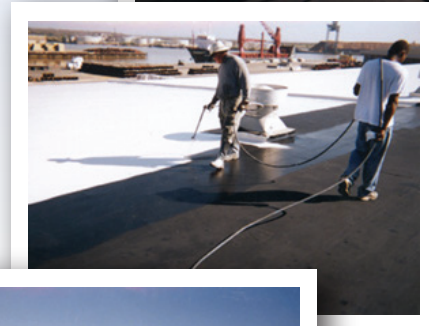
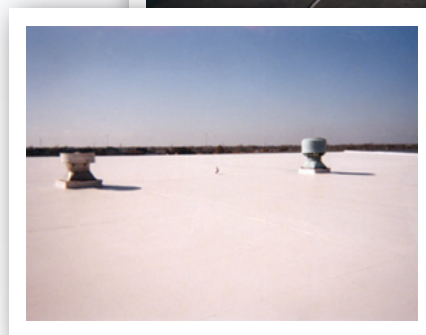
This EPDM membrane was approximately ten years old and at the time of the job leaks were random throughout the system. The building owner wanted a coating system to waterproof the roof, to cut down on the heat within the building, and to prevent future degradation of the membrane.

The WeatherStar Coatings approved Dealer cleaned the membrane using our Etching Primer 920, which is specifically designed to clean carbon and dirt off EPDM. The contractor applied the Etching Primer 920 with a garden sprayer then power-washed the roof using 3,000 psi. of pressure. He then began waterproofing the roof by applying our Silicone 410, and polyester fabric on all seams and penetrations that were causing the building owner problems.

After he completed waterproofing the system, the approved Dealer applied two coats of WeatherStar Coatings bright white Silicone 410 to the entire roof area to form a seamless, elastomeric membrane that will last for at least ten years.
