Gravel Built Up Coatings Restoration Case Study

This case study shows what a typical gravel built up roof looks like when it is twelve to fifteen years old and then after a Polyurethane Foam and the WeatherStar Coating System have been installed.

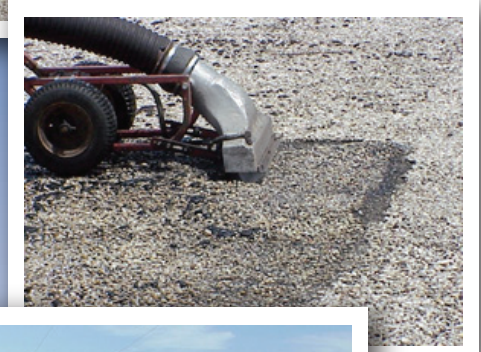
The AWS independent Dealer first takes off all the loose gravel on the roof and thoroughly cleans the substrate. In this case he accomplishes both by wet-vacuuming the roof. This ensures the polyurethane foam will adhere to the existing roof substrate. We always recommend a moisture survey before installing foam to ensure a successful job. If moisture is found in existing roofing system, the contractor will remove wet areas before installing Polyurethane Foam.

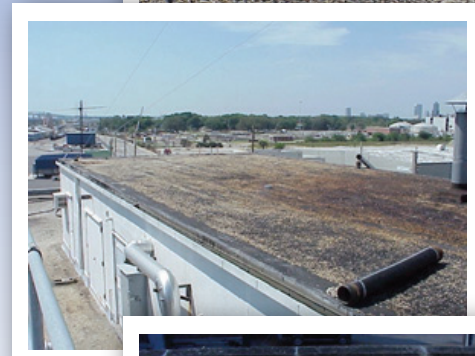
The foam is sprayed on the roof at a minimum of 1 1/2 inches to seal the entire roof area. Special care is taken around parapet walls and penetrations to make sure there is a tight seal.

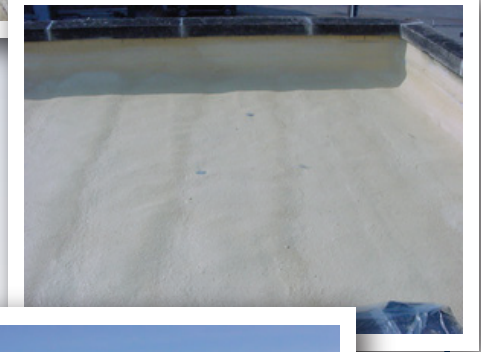
After the foam is installed in order to protect the foam from the sun's ultraviolet rays, the approved Dealer applies two coats of a WeatherStar top coat. Options include Acrylic 211 on roofs with a positive draining slope and on flat roofs that don't drain water well, we recommend either the Urethane 520 or Silicone 410. Without the coating, the foam would quickly break down under UV rays.

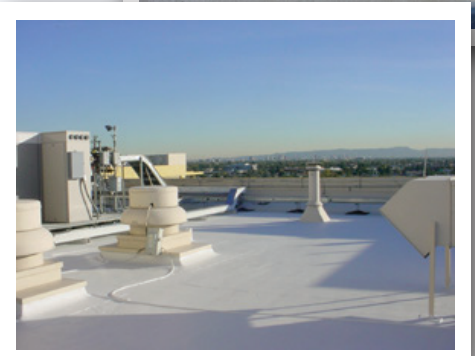
The foam and WeatherStar Coatings system not only gives the building owner an outstanding waterproof solution, it also adds an R10 insulation value for his building.
(Foam sprayed at 1.5")
